## Architectural Description & Surviving Character-Defining Features

The New Durham Meeting House reflects three major eras of construction: 1768-1770 (building was framed and enclosed), 1791-92 (pews, pulpit, canopy and gallery added), and 1838-48 (building cut down to a single story and parts of interior finish). Its current appearance reflects that last era, although the frame dates from the original construction period, as does a small amount of interior finish.

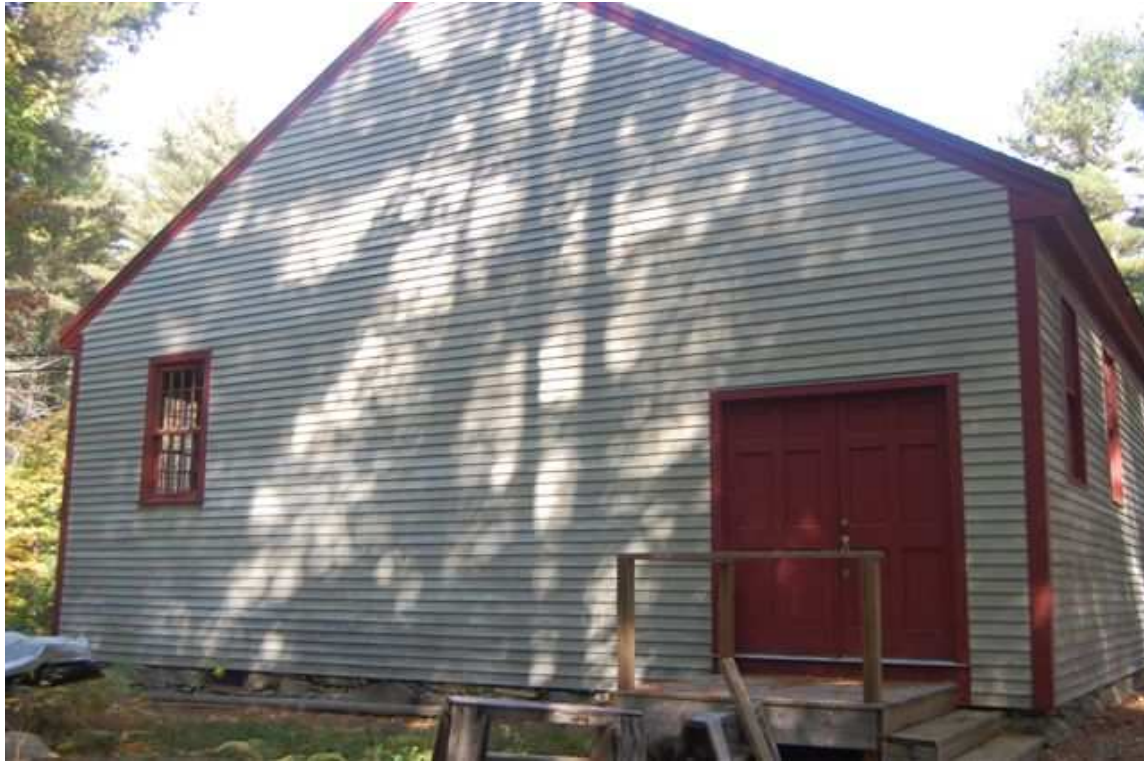
*Detail of rear (southwest) elevation. Double doors date from late 1980s, installed to infill a barn-type opening created in 1912. After the building was cut down in 1838, there was a likely another window in the middle of this bay, placed similarly to that on the opposite gable end.*

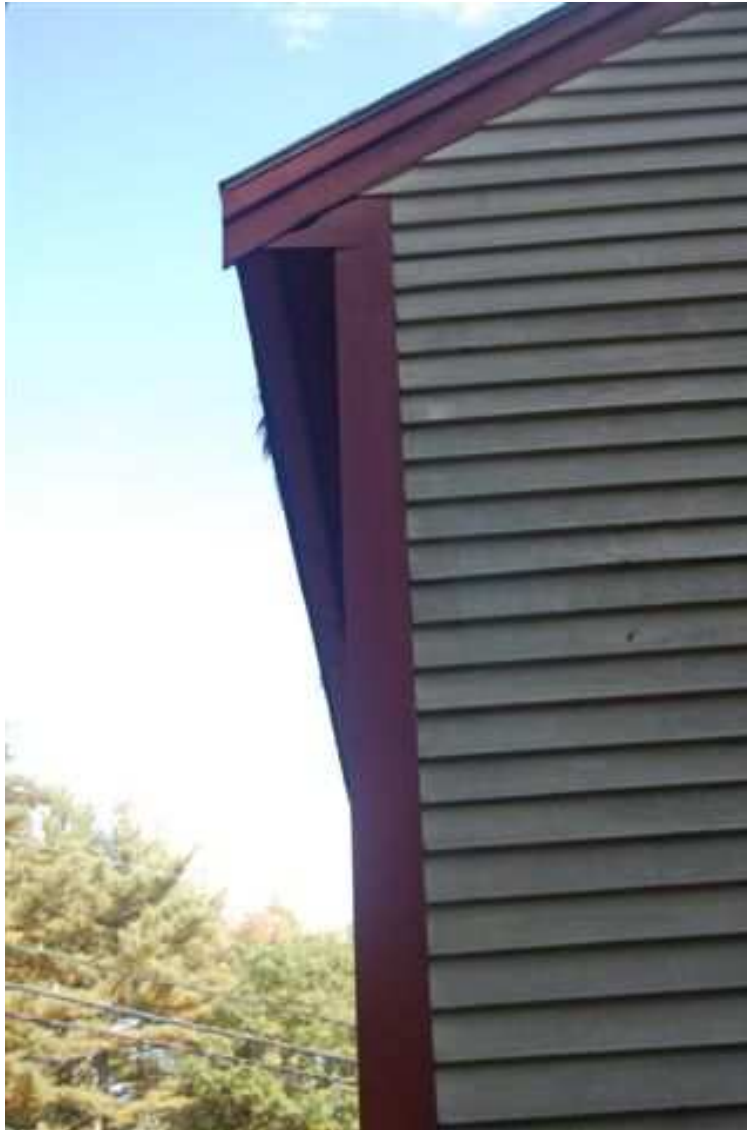
*Detail of replacement siding and trim*

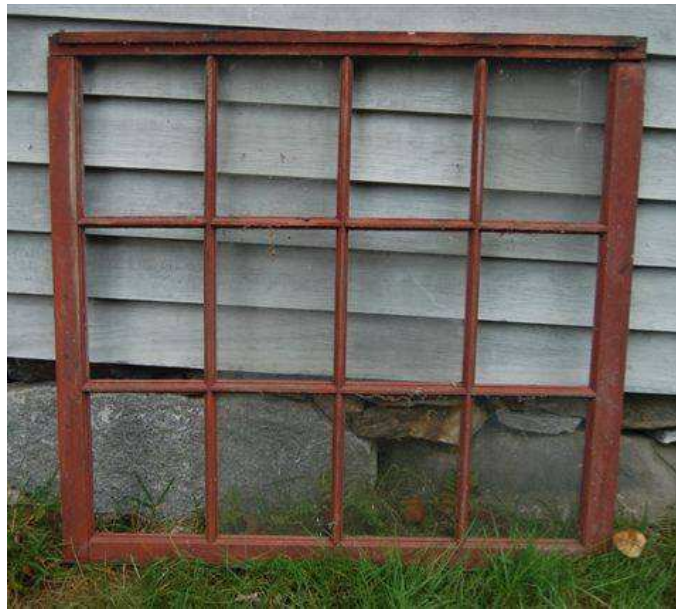
All of the window frames and sash date from the late 1980s. The sash are double hung, 12/12, with 7" x 9" glass. The opening for the window frame is slightly smaller than that which appears in the late 19<sup>th</sup> photographs. (The photographs also show the original windows had somewhat wider trim boards that abutted the eaves of the building.) A single, early, twelve-light sash survives in the building. Its muntin profile is more akin to a 1792 date than 1770, suggesting at least some window sash was replaced when the building underwent major work in 1792. Since the late 19<sup>th</sup> century photographs also depict 12/12 sash, it is likely the 1792 sash was retained

when the building was cut down. This one surviving sash would serve as a useful prototype should the existing windows ever need to be replaced again.

*At left: detail of a replacement window. At right: sole surviving historic sash, likely from the 1791-92 era*

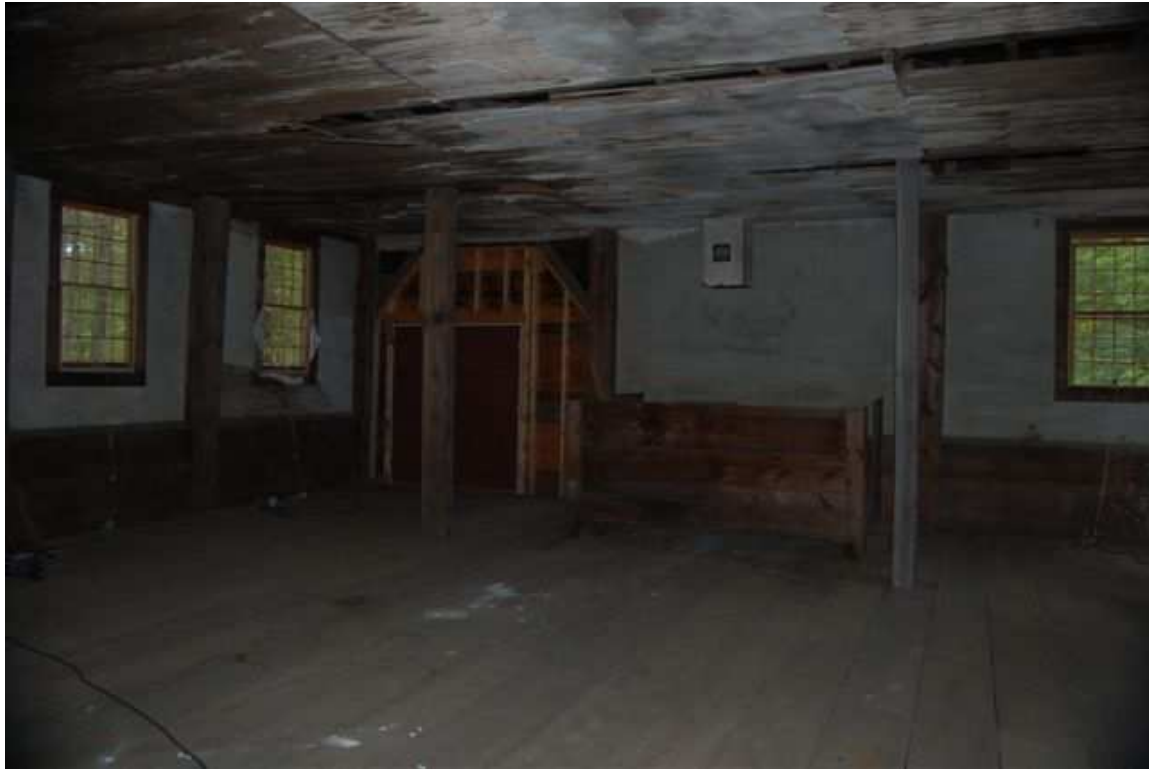
*Interior view looking south showing southeast and southwest (rear) walls. Interior posts are not original. Wide opening in far corner was created for a barn-type door in 1912.*

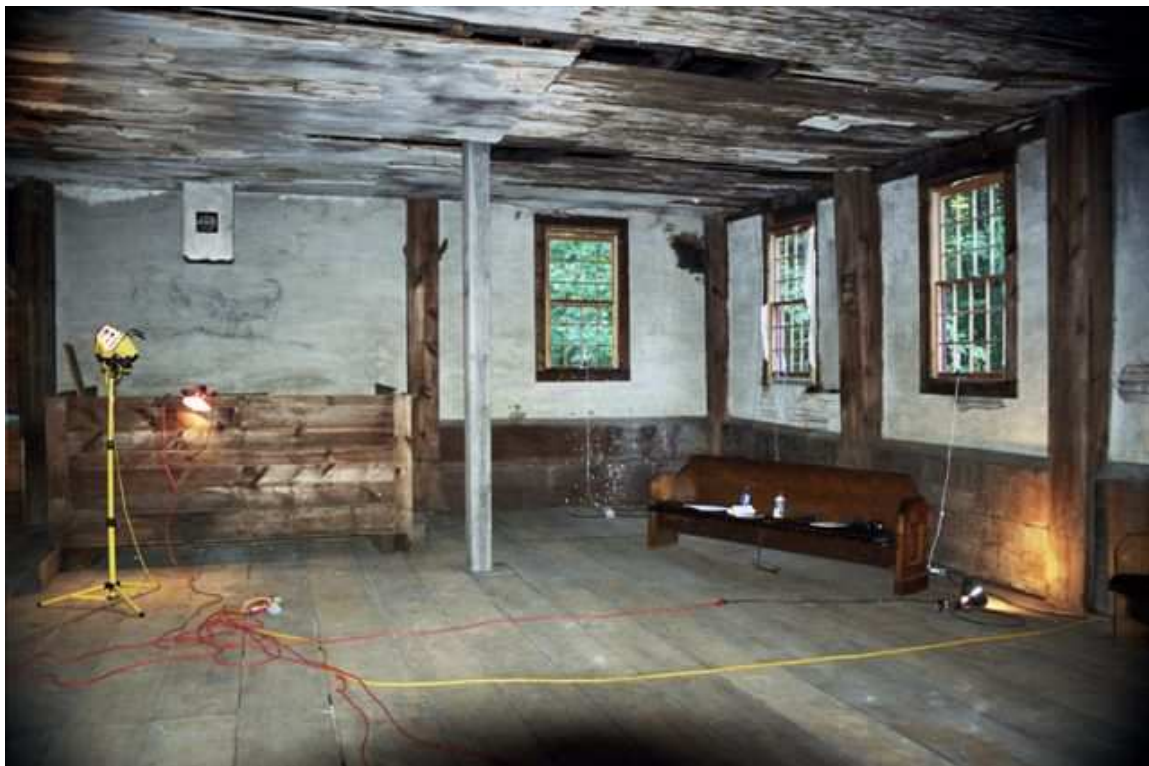
*Interior view looking west showing southwest (rear) and northwest walls. Interior post in foreground is not original.*

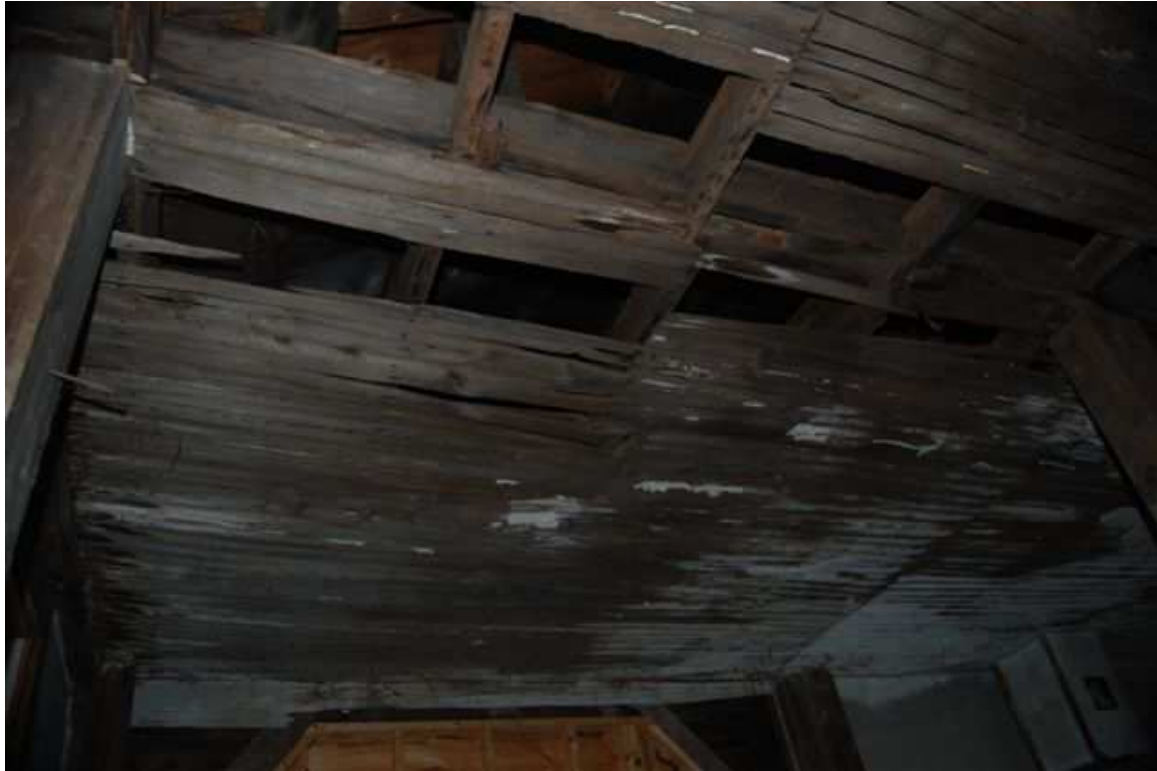
*Ceiling:* The ceiling is split/accordion lath; none of the plaster remains.<sup>1</sup> Cut nails hold the lath in place to the ceiling joists, indicating the existing ceiling dates from either the 1838 or 1848 remodeling activity. (Oddly enough, there is no physical evidence of an earlier plaster ceiling and/or framing: the building has its original collar ties, and there is no sign of joist pockets in the ties. If the ceiling was above the ties, one would expect to see a plaster shadow line—again missing. Yet, a meeting house open to the roof frame would have been highly unusual.)

*Detail of ceiling, showing split/accordion lath and joists*

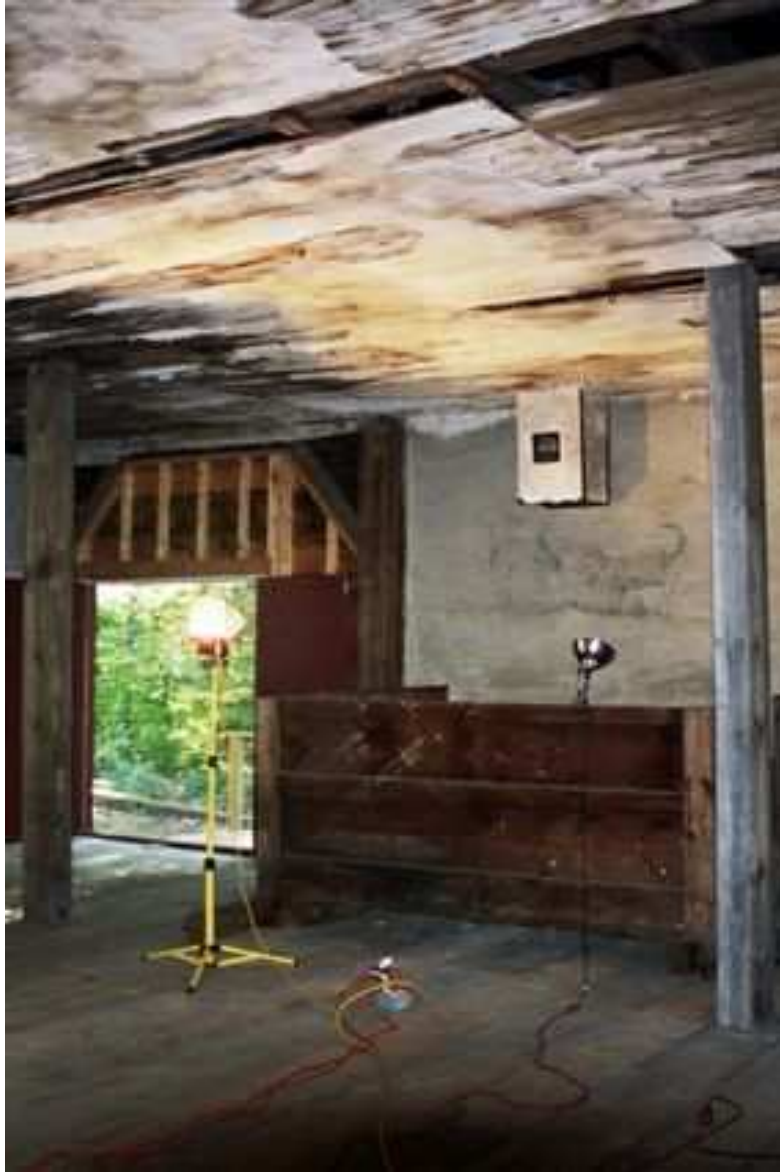
- **Chimney:** Part of the chimney that serviced the stoves remains at the southwest end of the building. (It originally extended above the ridgeline.) It is constructed of brick and plastered over. The chimney was in place by 1848 and possibly earlier.

*Remains of chimney near southwest (rear) wall*
