Existing Conditions Survey

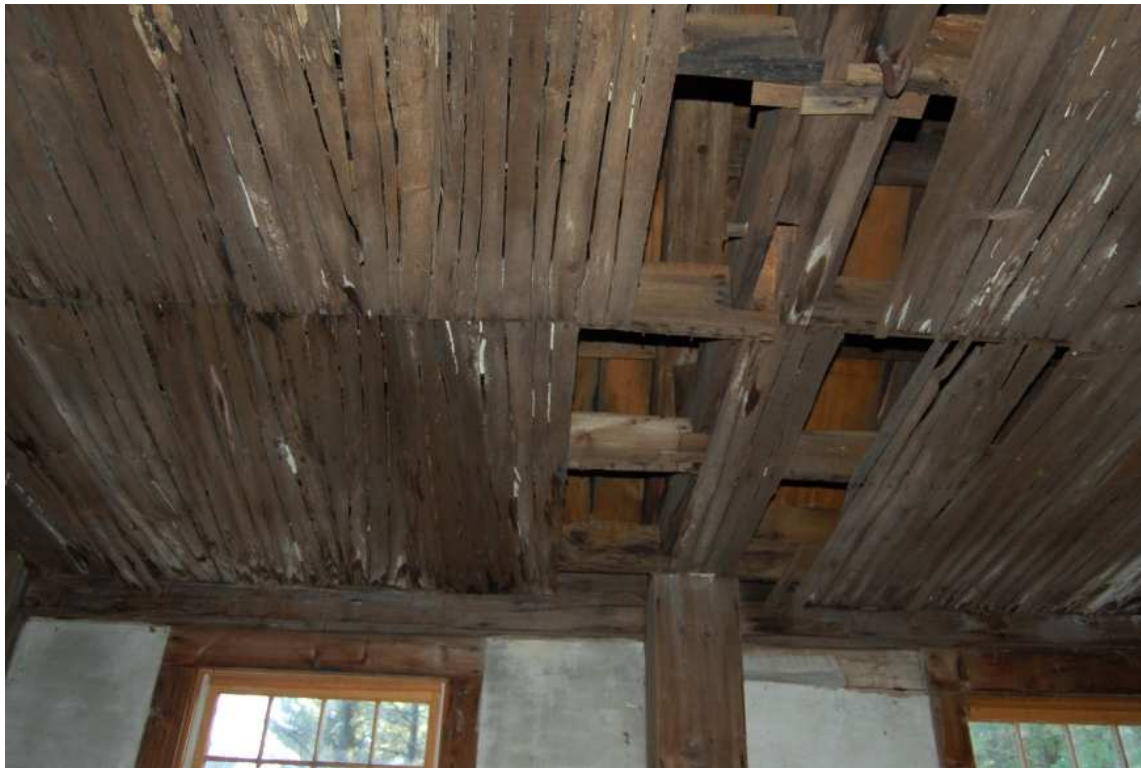
Physical evidence indicates that the ceiling was likely lathed/plastered for the first and only time during this period. The weight of the additional ceiling joists/lath/plaster, coupled with yearly snow load pressure on the rafters, caused the collar ties to sag and the ceiling to flex, thereby breaking the “keys” of the plaster, allowing the plaster to disengage and fall down.

Looking up at the joists and lath of the ceiling, where the plaster has fallen away.

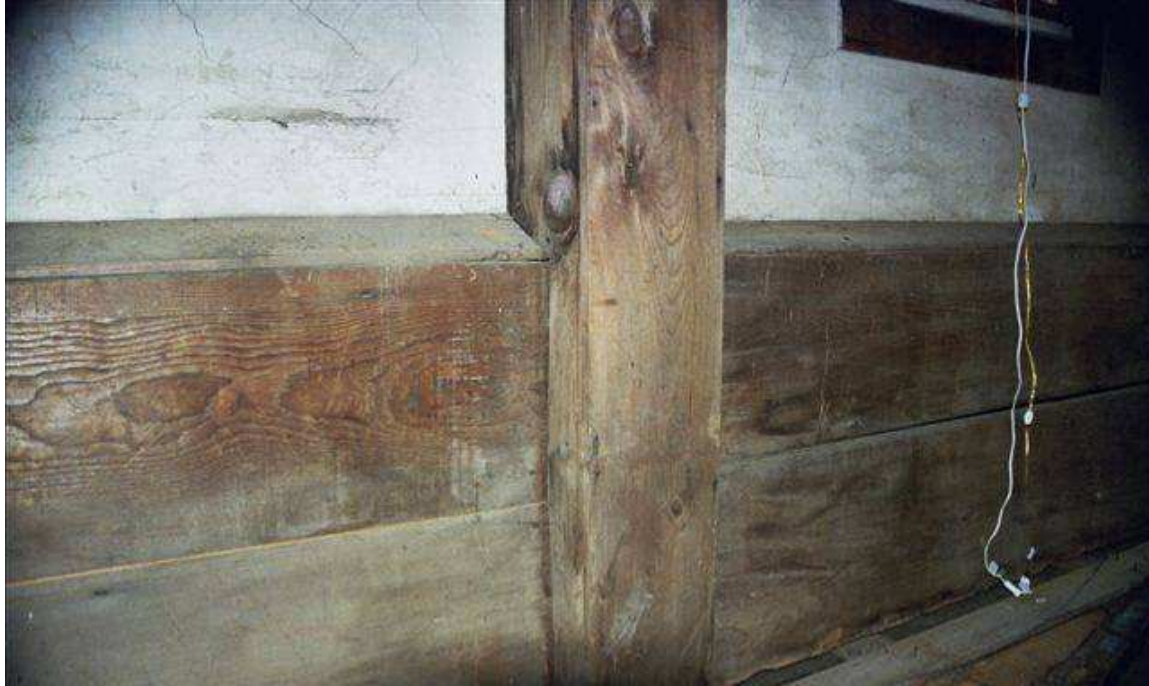
The interior post covers and perimeter wainscot cap are unpainted and are held in place with cut nails also consistent with the 1838 to 1847/1848 date.

A section of the first floor wall showing wainscot with cap and a covered post

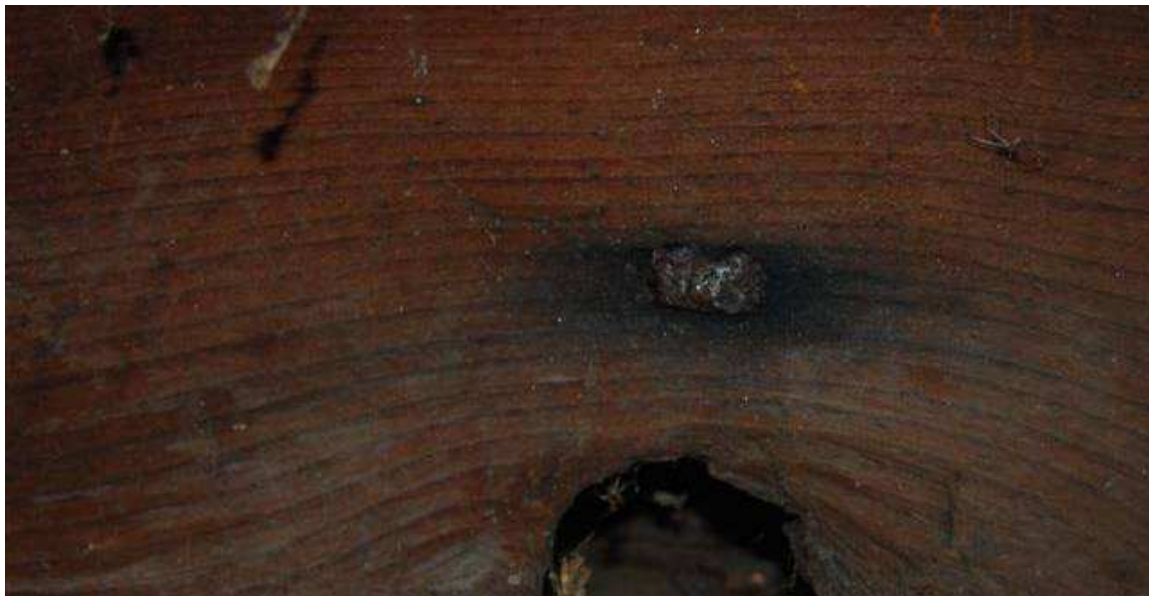
The interior architectural elements appear to date from the 1838 to 1847/1848 time period, which is after the building was cut down to a one-story structure. The only exception is the perimeter wainscot, which appears to be from ca. 1792. These boards (unpainted or with a slight wash) are held in place with hand wrought nails and in some areas they are held in place with a mixture of hand wrought and cut nails, which may indicate a re-use of older material, including nails.

Detail of a butterfly, wrought iron nail in the wainscot

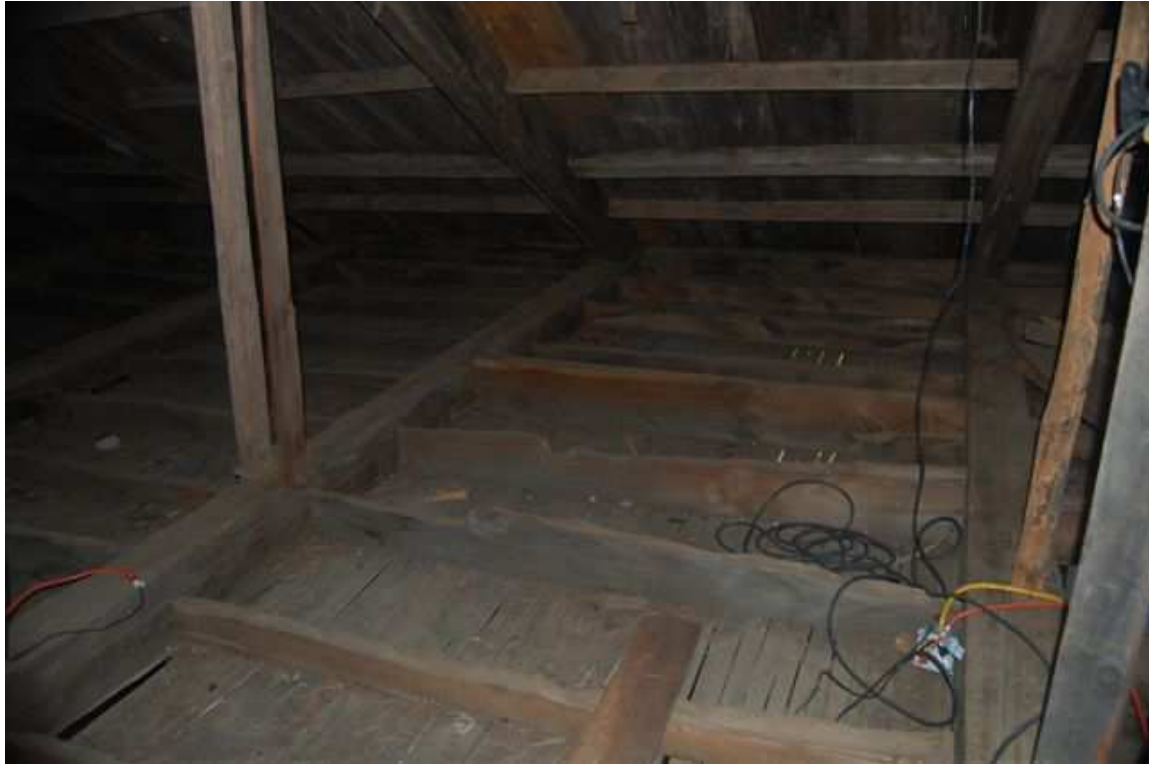
The structural supports for the ceiling lath and plaster are re-used water-powered sawn floor joists that have been roughly split and then attached to the collar ties with cut nails. These floor joists most likely were the floor joists from the galleries and were split and re-used after the building was cut down to one story in 1838. The lath is attached to these added floor joists with cut nails, and no earlier nail holes appear in these ceiling joists.

A view of the ceiling joists from above.

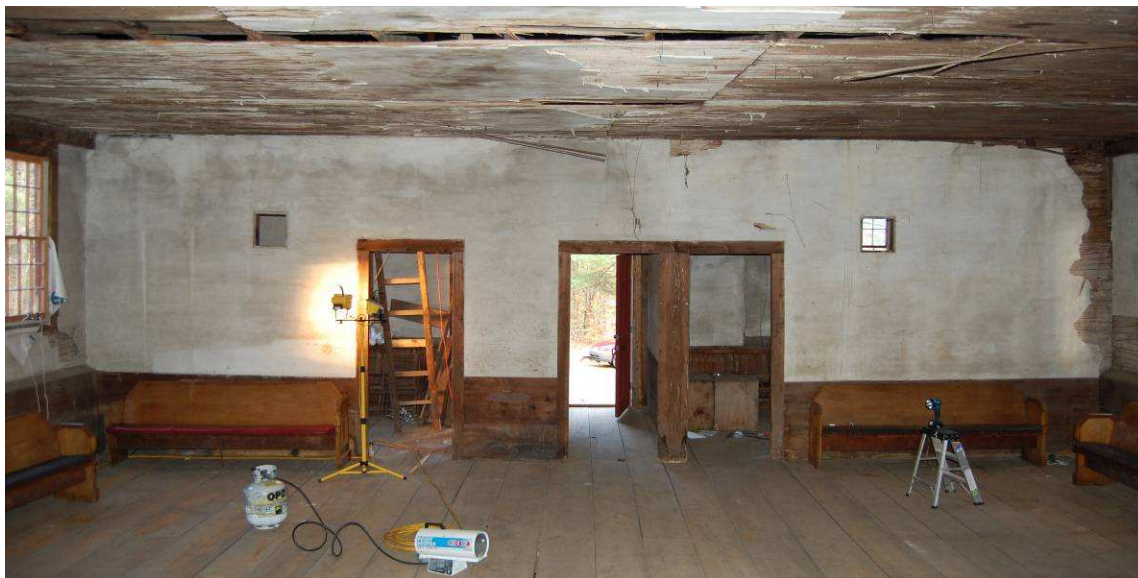
The chimney appears to date to 1847/1848 as well. The small openings in each of the two smaller rooms indicate a stove in each room. Each stove would have its own stove pipe that exited through the hole in the wall and then run along the ceiling in the meeting room to connect together before entering the chimney.

Looking northeast toward the two small rooms at the front of the building. The square openings once held stove pipes connecting the stoves in the small rooms with the chimney on the southwest wall.
